Photos and illustrations from IIC Factual Report

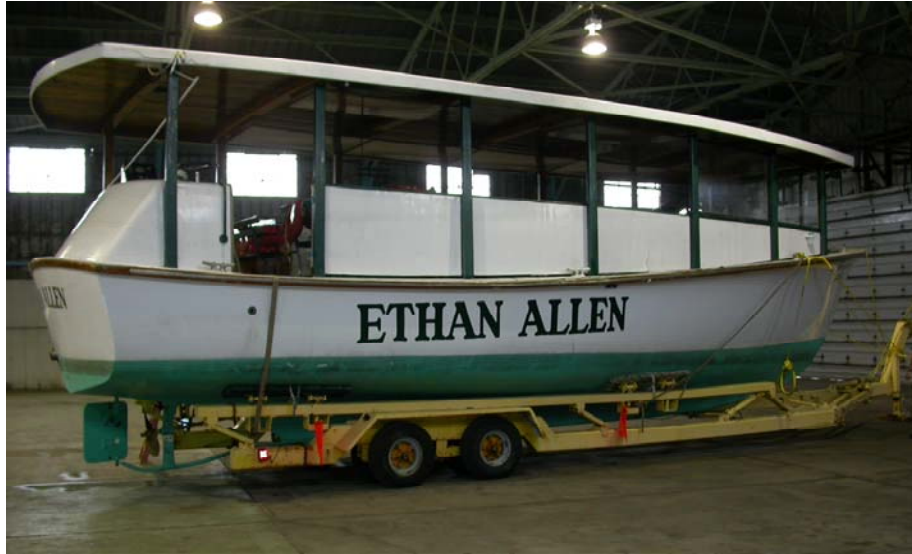
Figure 1. *Ethan Allen* after the accident.

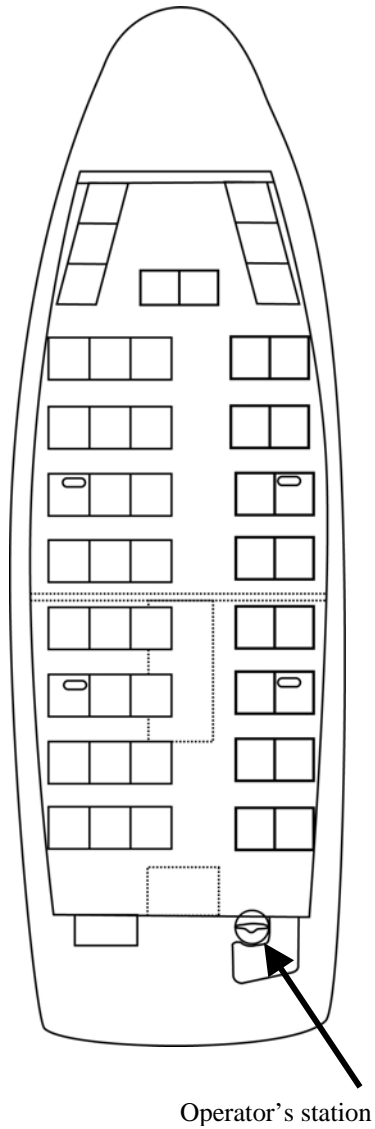
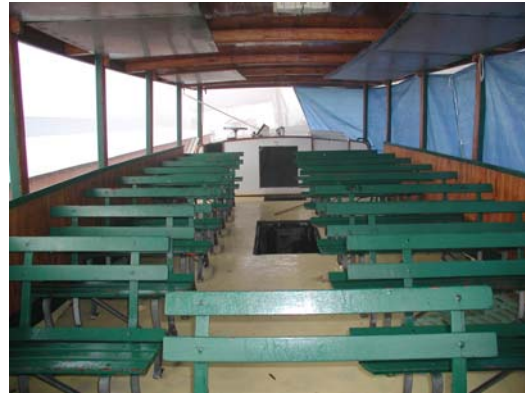
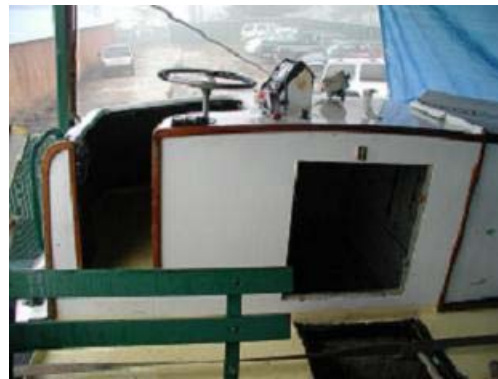
(a) Layout of vessel interior.

(b) Vessel interior, looking aft. Side windows are in up position and hinged to canopy roof, as during accident voyage.

(c) Closeup of operator's station.

Figure 3. Three views of *Ethan Allen* interior, showing passenger seating, operator's station, windows, and canopy. Photos were taken after the accident.

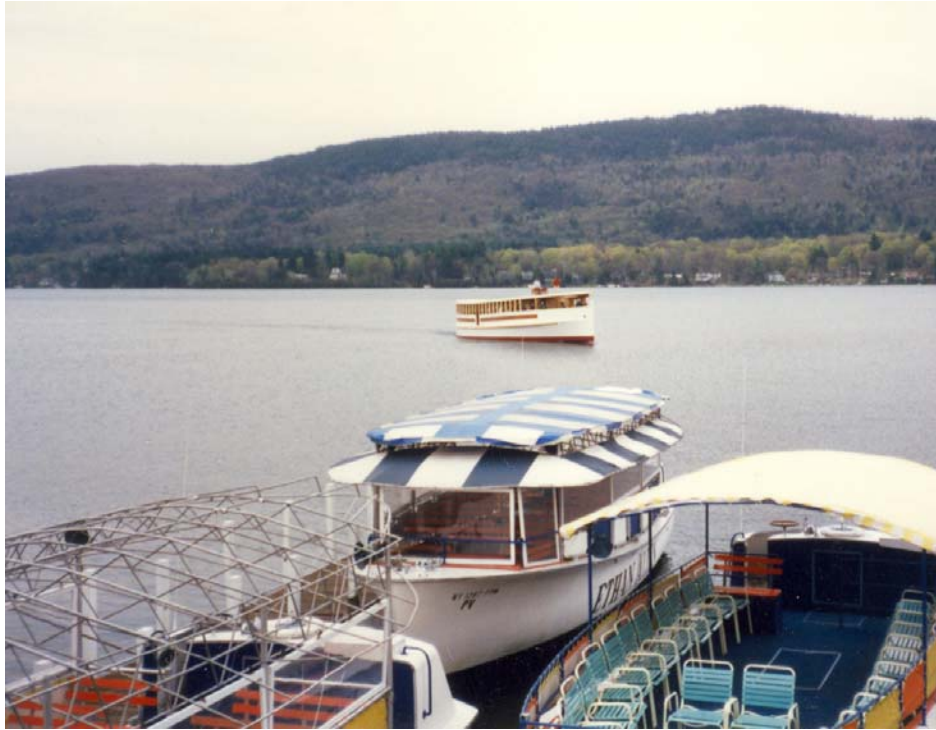
Figure 4. Canopies and metal framework on *de Champlain* (foreground left), *Ethan Allen* (foreground center), and *Algonquin* (foreground right).

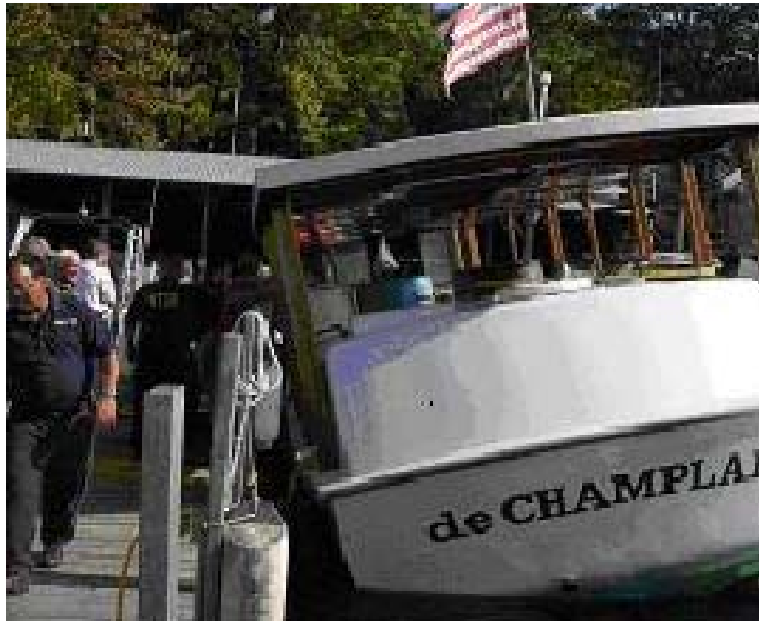
Figure 5. *De Champlain* after on-site stability assessment was terminated.
